Oxyzone International Pty. Ltd.

Maintenance and Repair of Oxyzone Ozone Cells

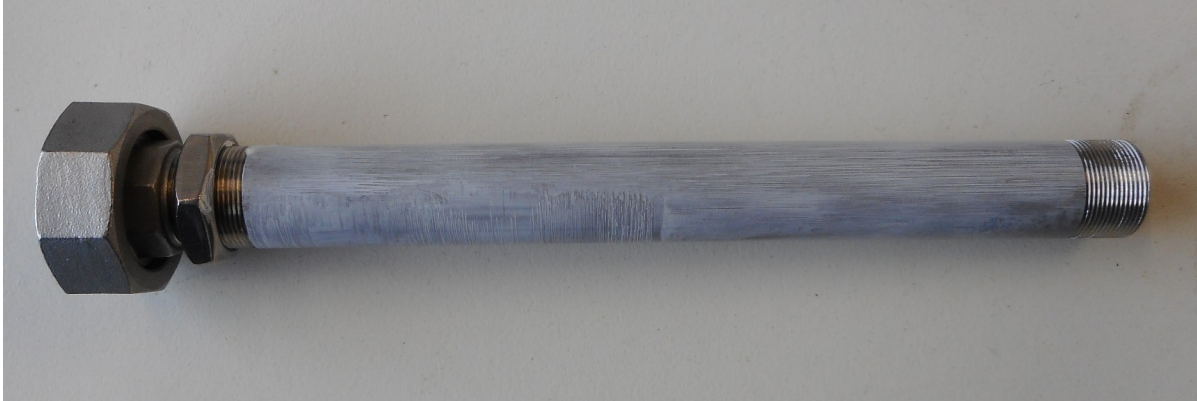
Reassemble the black heatsinks after lightly coating the tube with white heatsink compound. The thinnest, most uniform coating of the compound is all that is required.

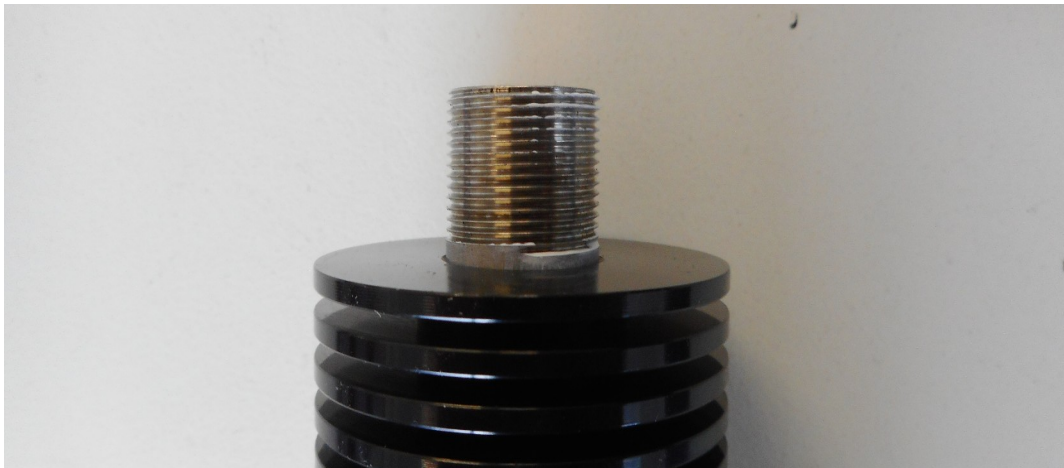
Adjust the large stainless steel nut to give a 2mm section of unthreaded stainless steel tube to be visible above the heatsink. This will provide for some compression of the large upper o-ring, & better sealing.

This picture shows the 2mm gap that has been adjusted using the large stainless steel nut. The 2mm gap should be set to the minimum thread gap. You can see a step down to where the thread stops. Set the 2mm gap here.

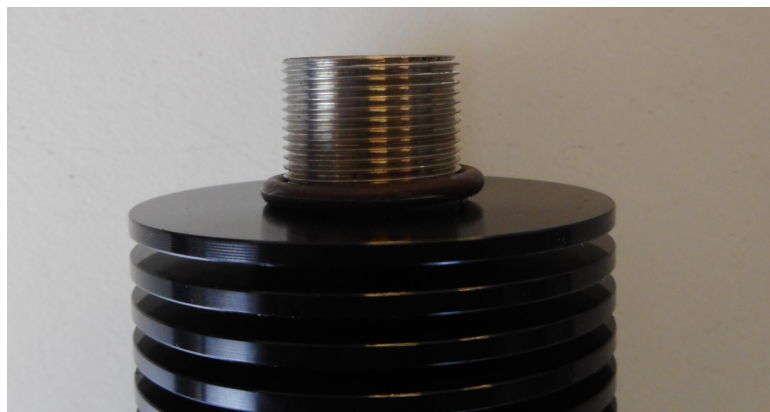
A large viton o-ring goes on next, over the threaded tube where the 2mm gap has been made.

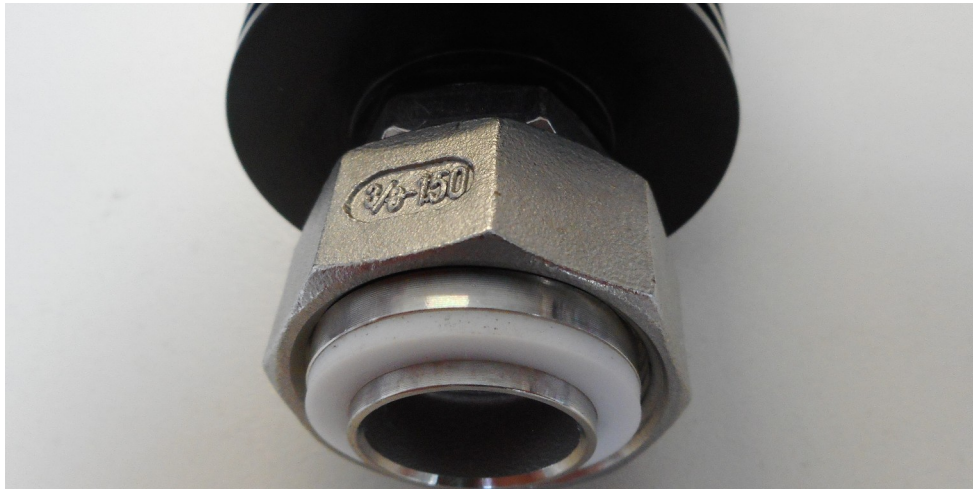
Check & replace if necessary the Teflon washer, or the viton o-ring in the unions at the base of the cell prior to fitting.
